# **Intel<sup>®</sup> Mobile Pentium<sup>®</sup> II Processor Specification Update**

Release Date: July 2000

Order Number: 243887-022

The Mobile Pentium<sup>®</sup> II processor may contain design defects or errors known as errata which may cause the product to deviate from published specifications. Current characterized errata are documented in this Specification Update.

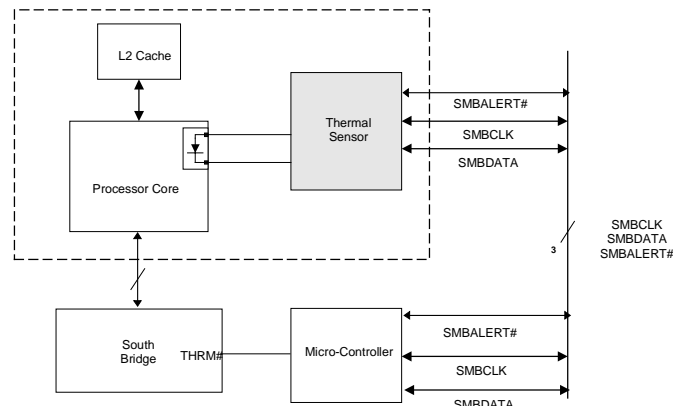
**Figure 1. An Example of Microcontroller Driven Thermal Management**

**Problem:** The Mobile Pentium II processor and the Pentium II Processor Mobile Module have a thermal sensor that monitors the processor core's temperature. Please note that desktop systems could have a similar thermal device. The thermal sensor asserts SMBALERT# if the processor temperature exceeds the temperature limits set in the Alarm Threshold Registers ( $T_{HIGH}$ ,  $T_{LOW}$ ). It also sets the corresponding Status Register bits to identify the cause of the interrupt. Figure 1 gives one example of the how the SMBALERT# signal could be used in a system.

Under the conditions described below, the thermal sensor incorrectly generates the SMBALERT# interrupt. All of the following conditions must be met to trigger a false interrupt:
